ASTRONAUTICS DIVISION

STUDY OF OPTIMUM ENVIRONMENTAL  
PROTECTION AGAINST METEOROID  
PENETRATION

Contract No. NASw-416

Report No. 00.165

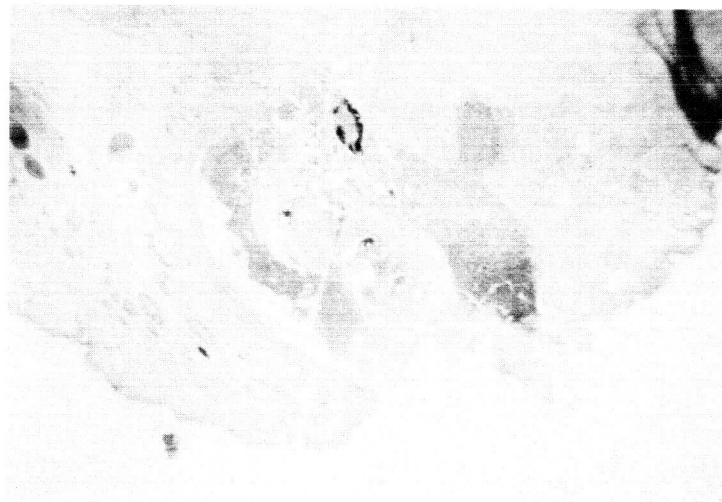
SHRAPNEL WOUND WITH INFLAMMATION

FIGURE A-4. PHOTOMICROGRAPHS OF SHRAPNEL WOUNDS PRODUCED BY SPALLED TARGET WALL MATERIAL OR PENETRATING PARTICLES

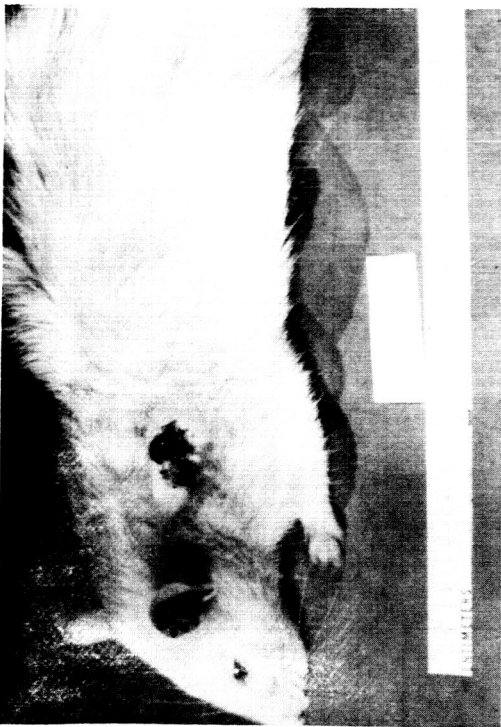
50% OXYGEN, 50% NITROGEN  
7 P.S.I.

FIGURE A-5. GROSS APPEARANCE OF SPECIMEN AFTER TEST UNDER VARIOUS CONDITIONS (SHEET 2 OF 2)
